Engineering Assessment

Insured Names

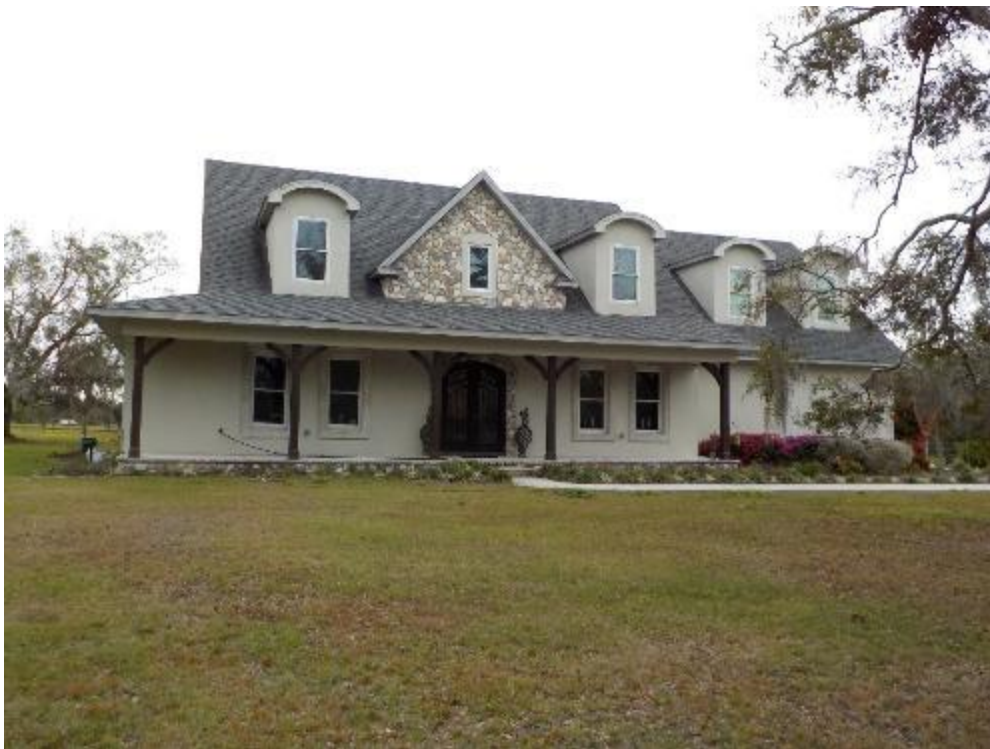
Photograph 1: Front Elevation (West-facing)

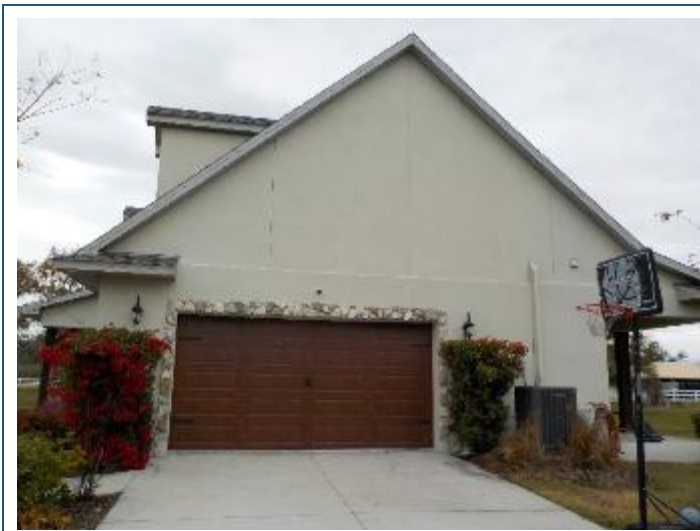
Photograph 2: Right (south) elevation

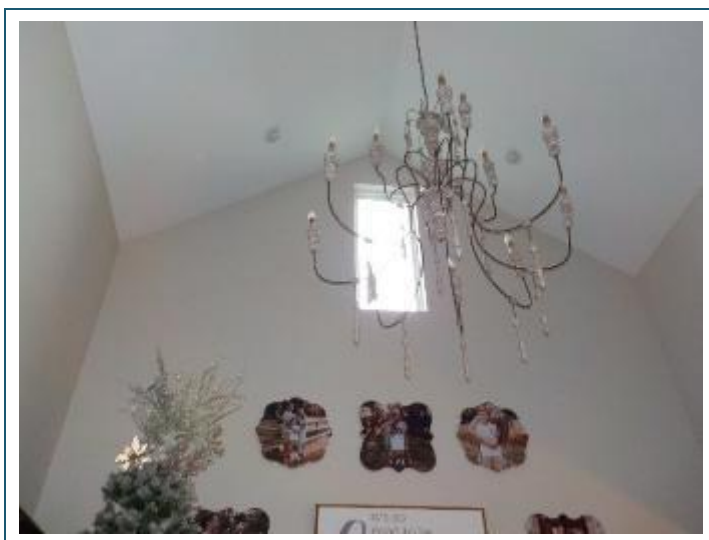
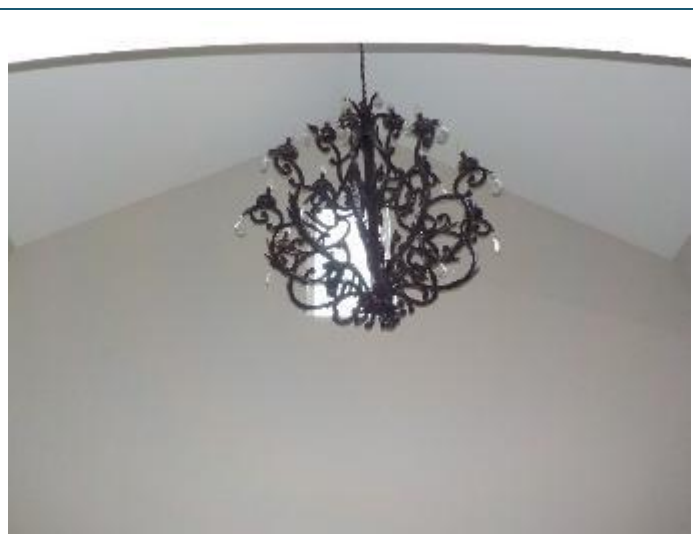
Photograph 12: Overview of interior

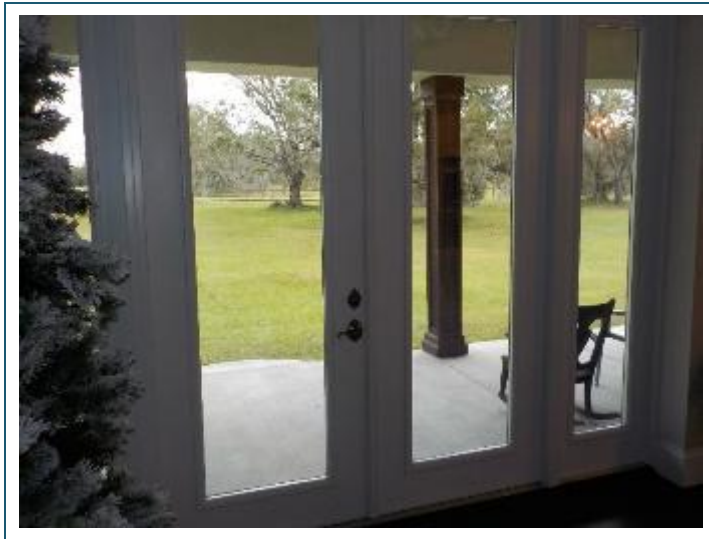
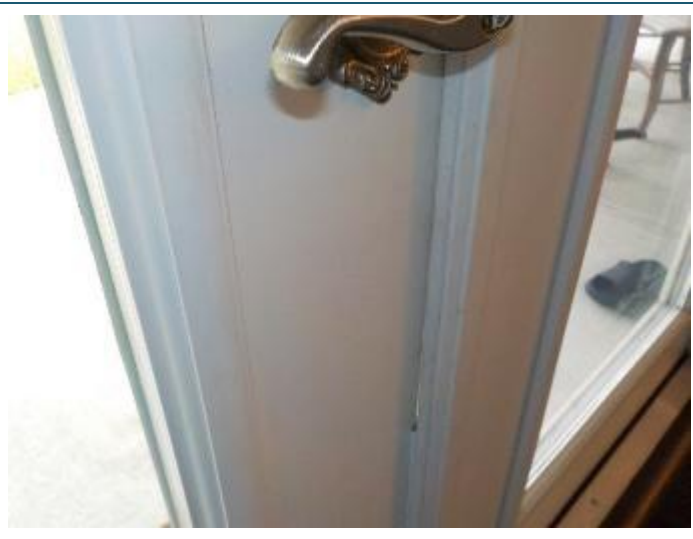
Photograph 14: French doors onto back porch from living room area

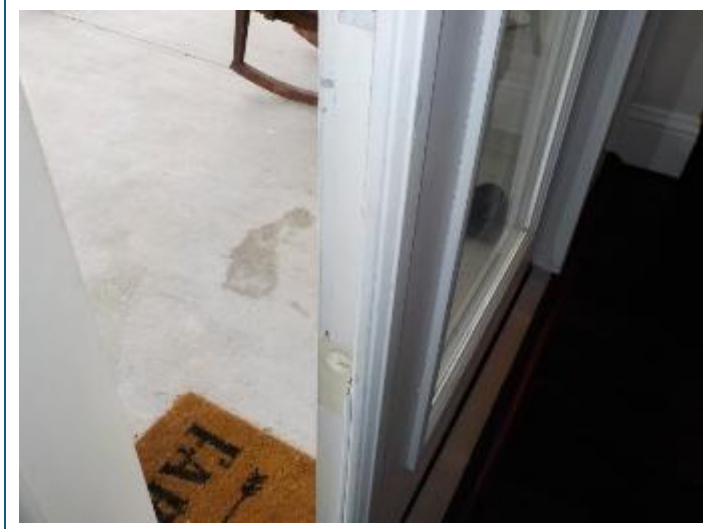
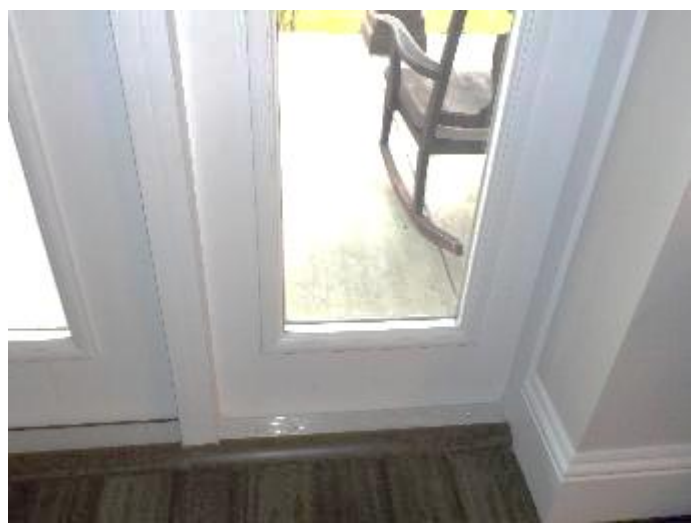
Photograph 16: No damage to French door frame

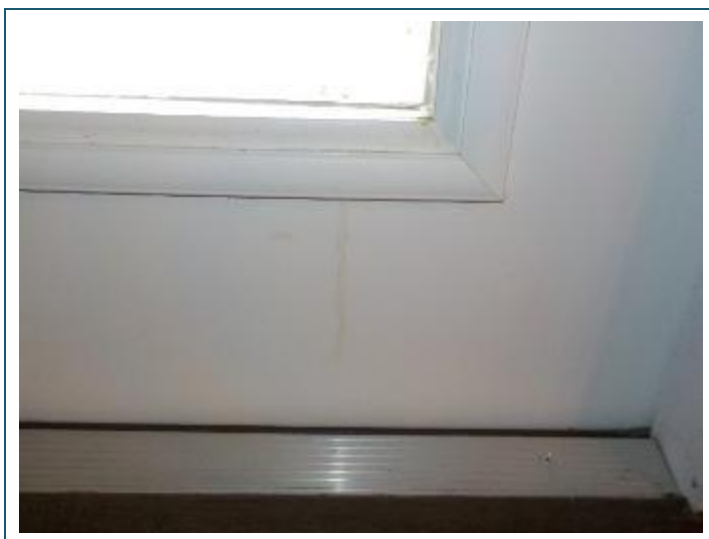
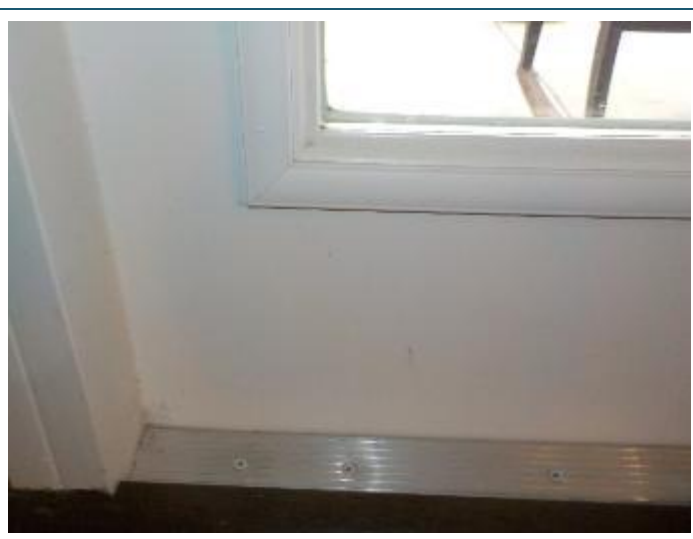
Photograph 18: Stains on door beneath window panel

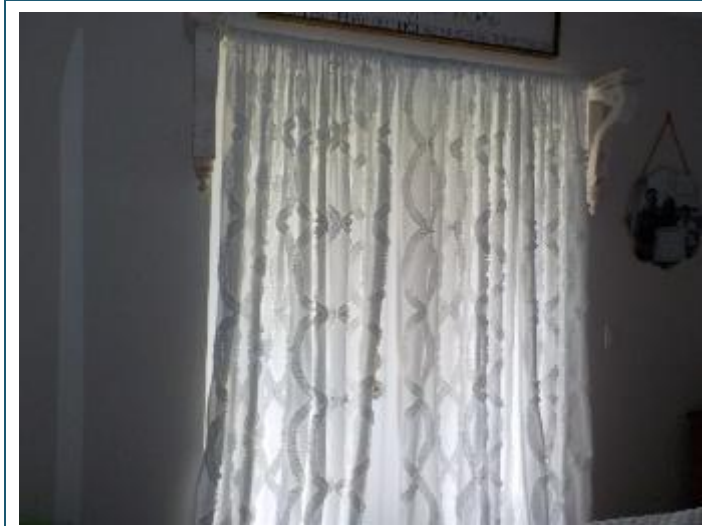
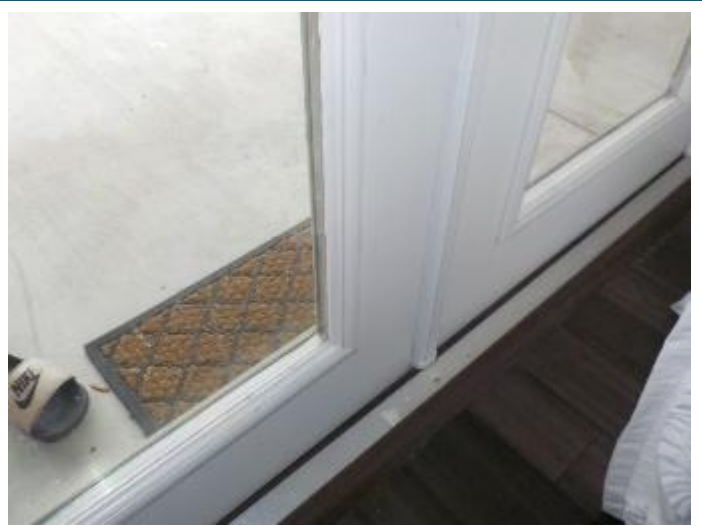
Photograph 20: French doors from master bedroom on to back porch

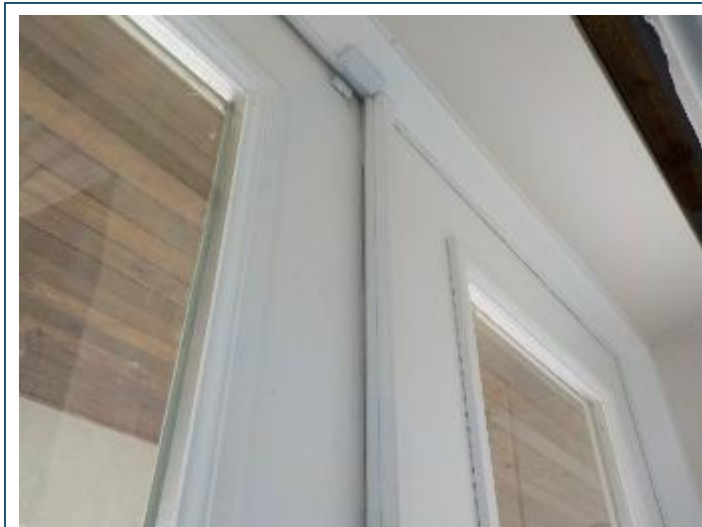
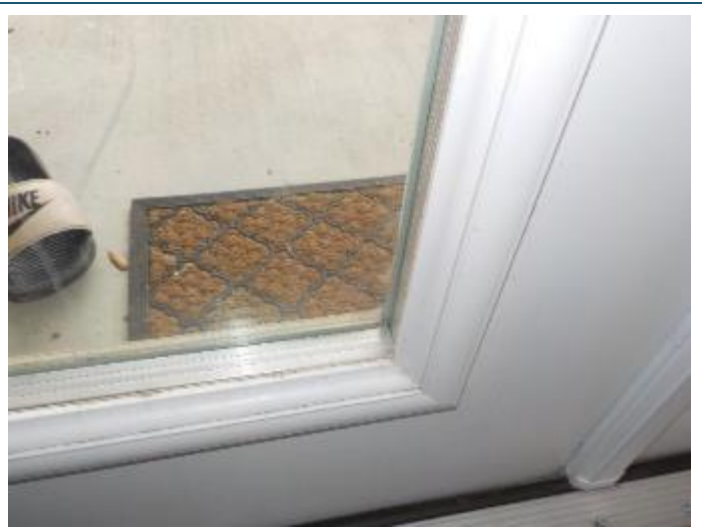
Photograph 22: No damage to door frame

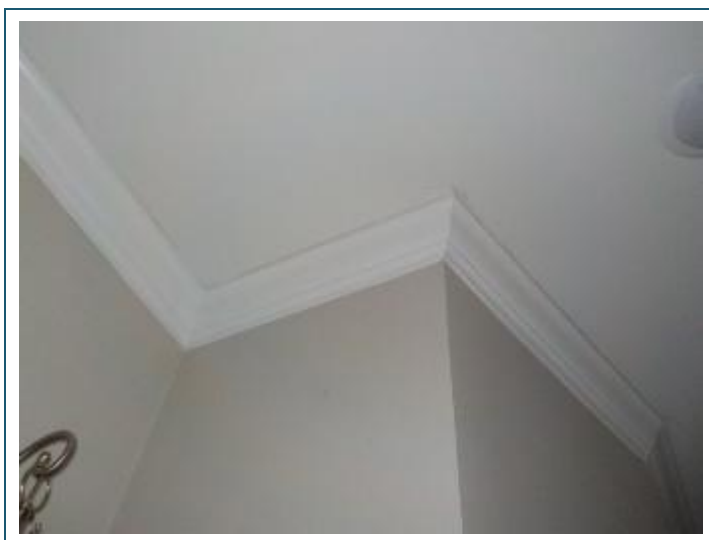
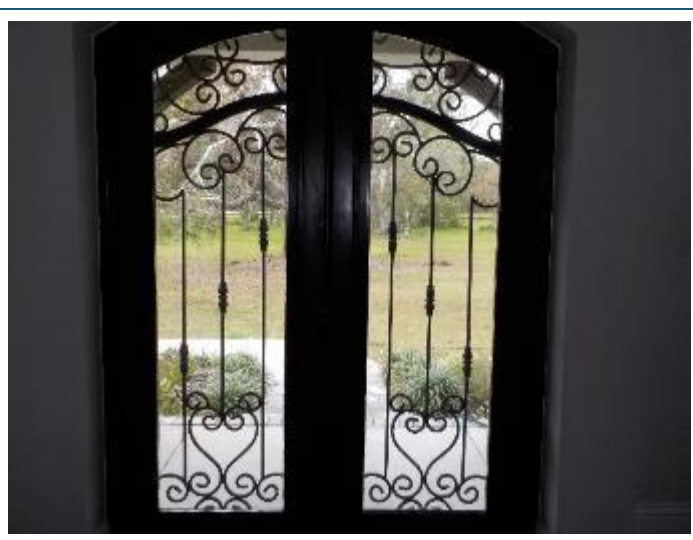
Photograph 24: Cracks/separations along crown moldings on ceiling (typical)

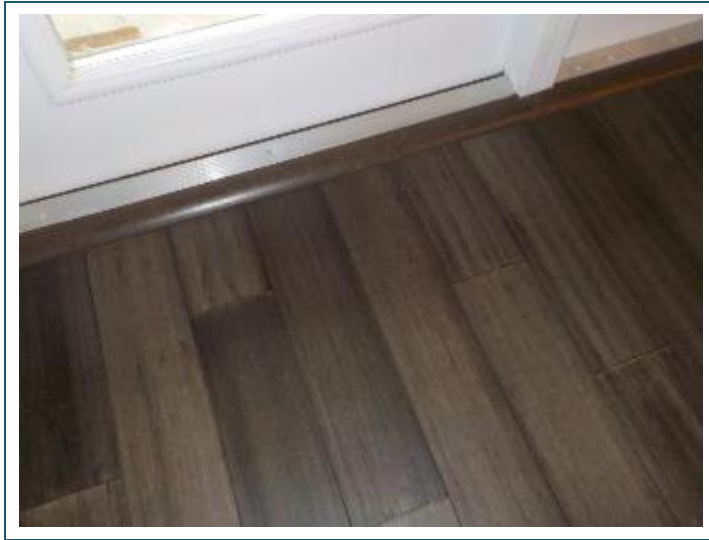
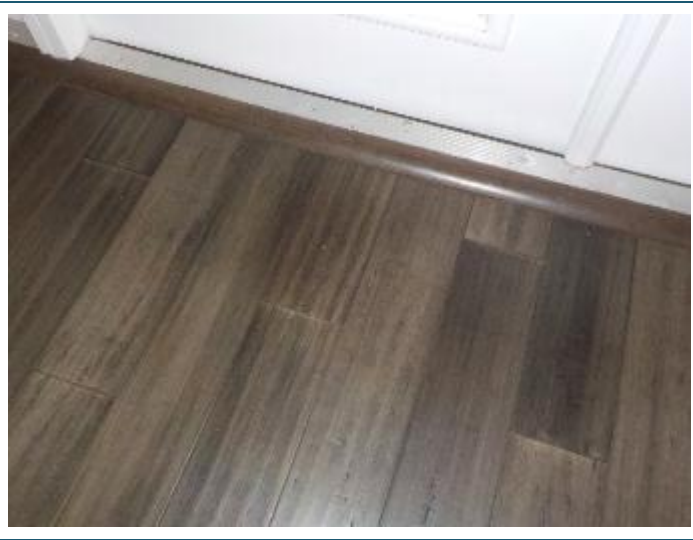
Photograph 26: No damage to flooring at front entry

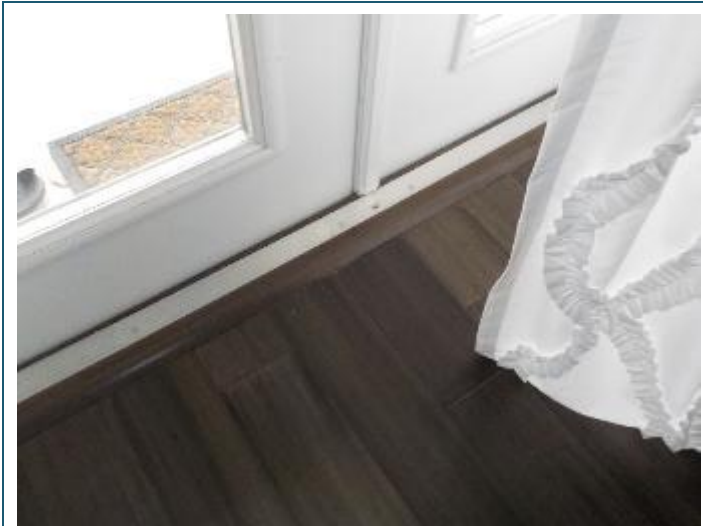
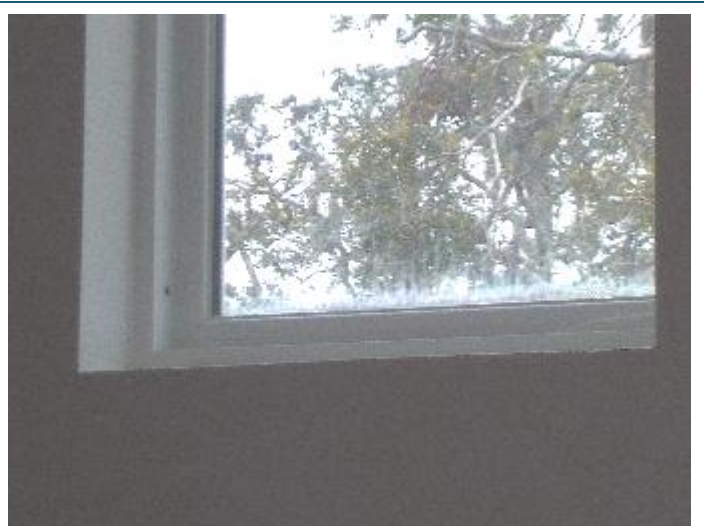
Photograph 28: No damage to flooring at French doors in master bedroom

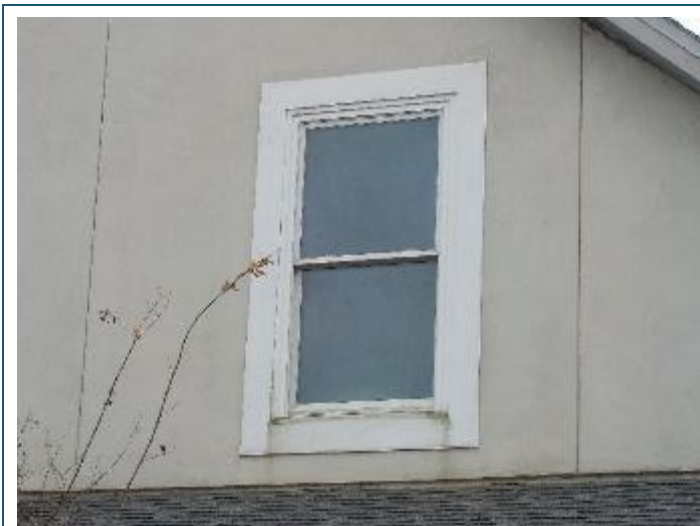
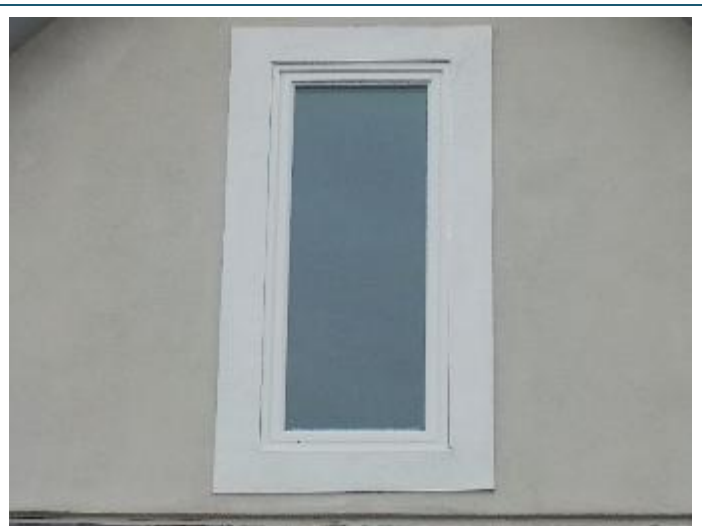
Photograph 34: Exterior view of window; no storm damage was apparent (typical)

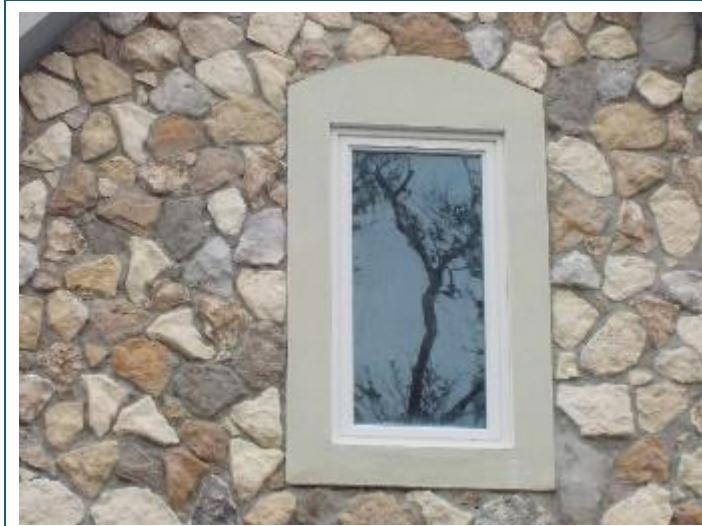
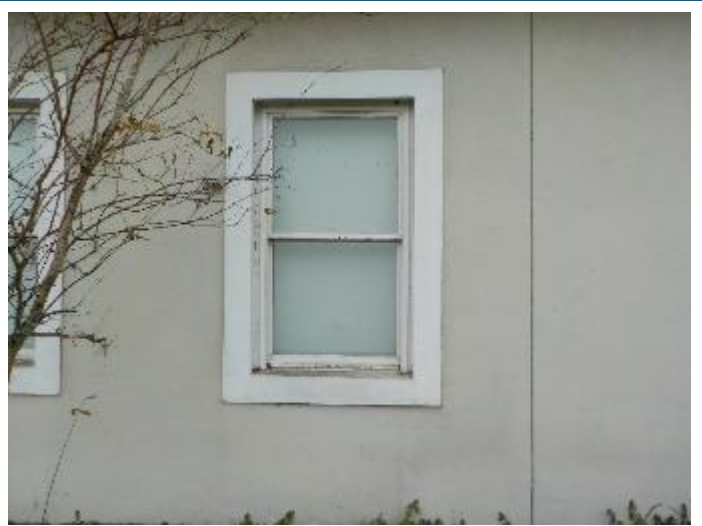
Photograph 36: Exterior view of window; no storm damage was apparent (typical)

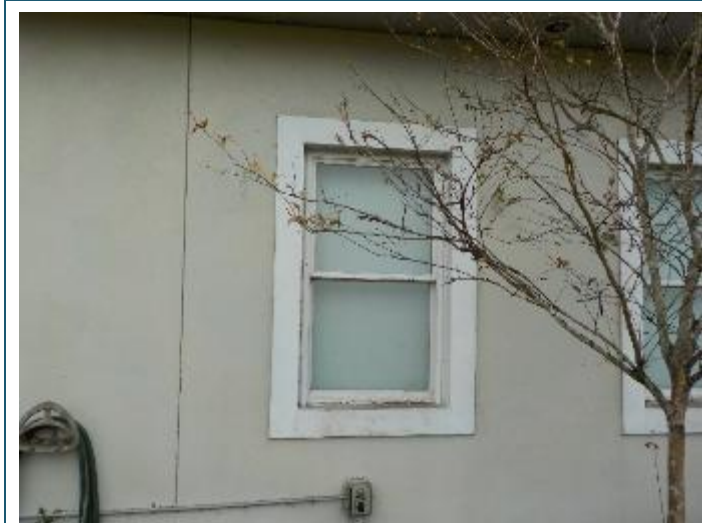
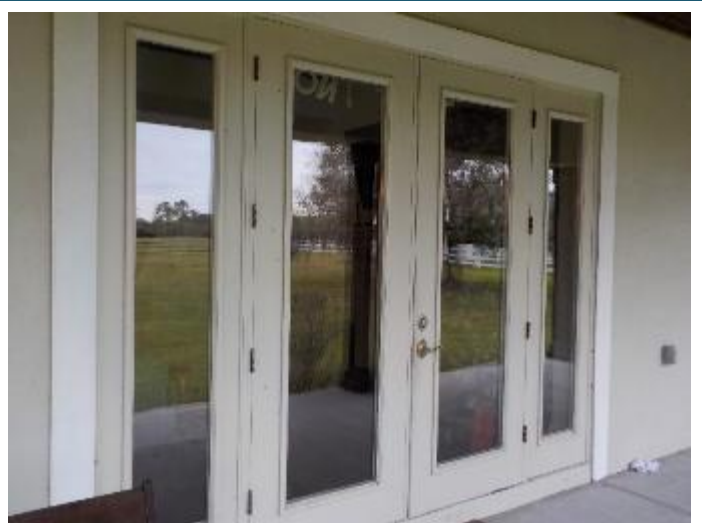
Photograph 38: Exterior view of window; no storm damage was apparent (typical)

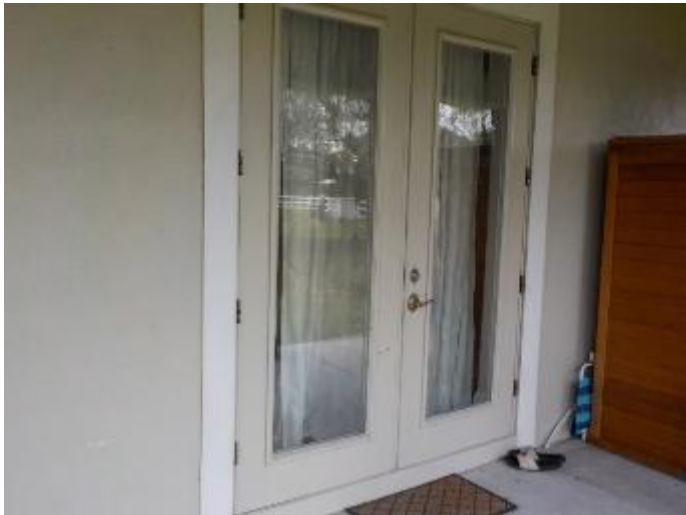
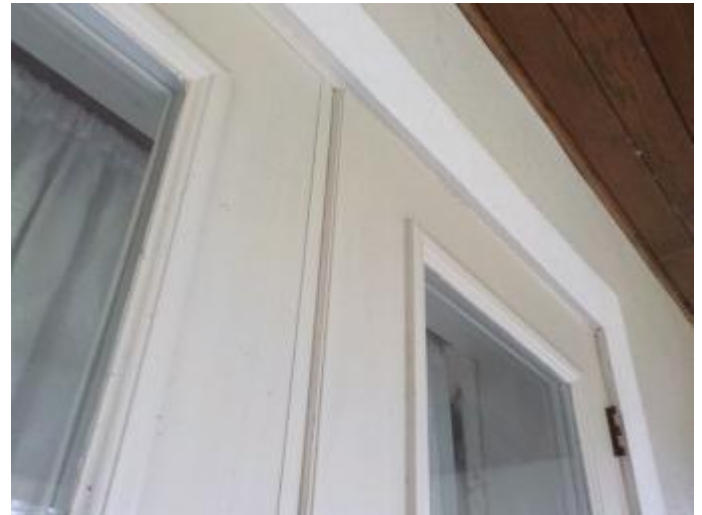
Photograph 40: French doors onto back porch from master bedroom; no storm damage was apparent

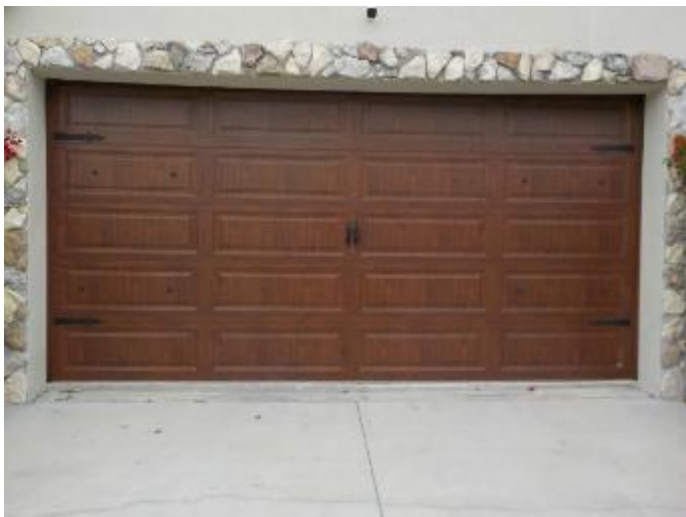
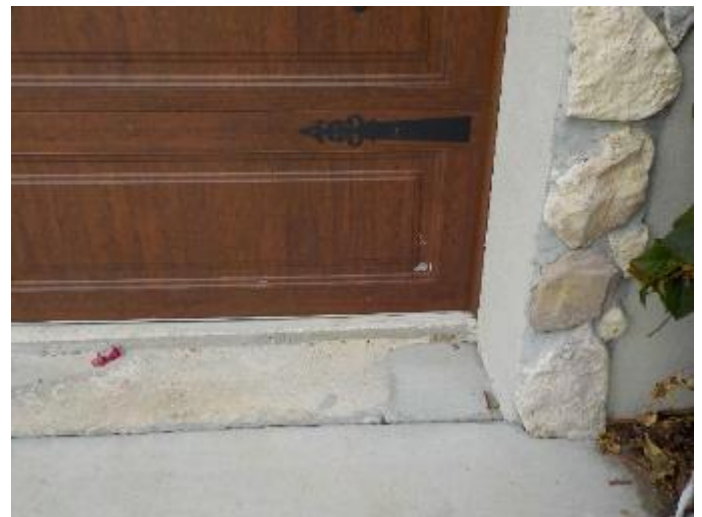
Photograph 42: Overview of garage door; no storm damage was apparent

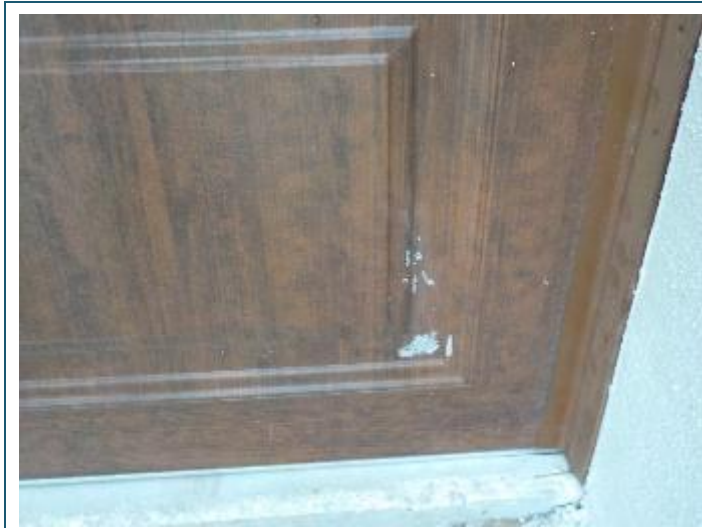
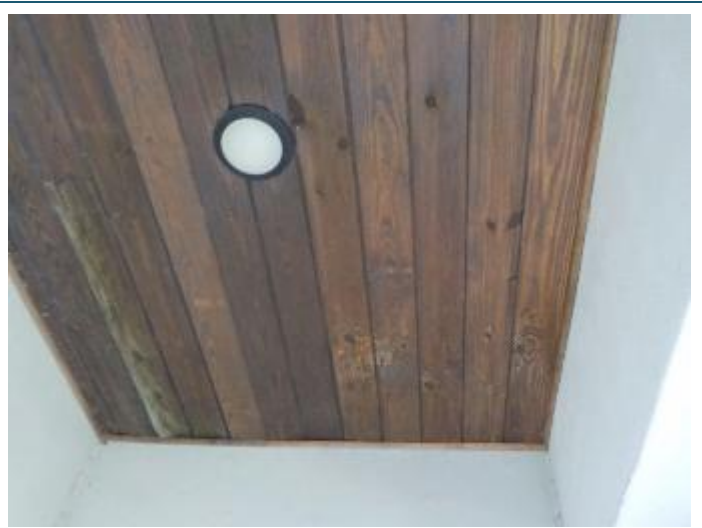
Photograph 44: Damage to garage door paint

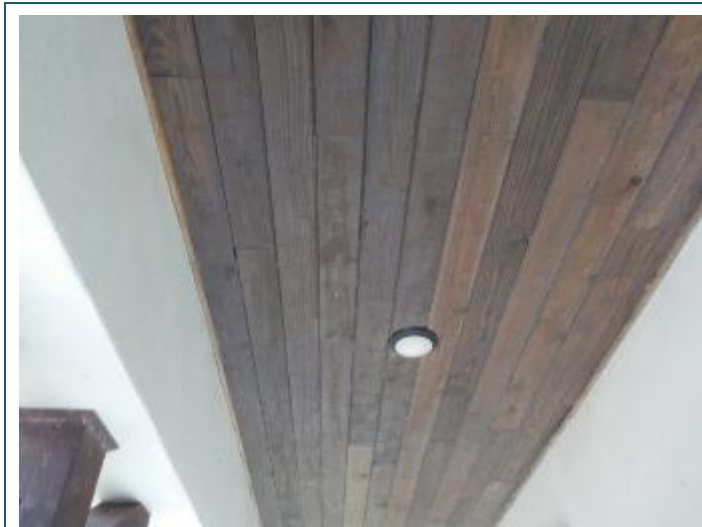
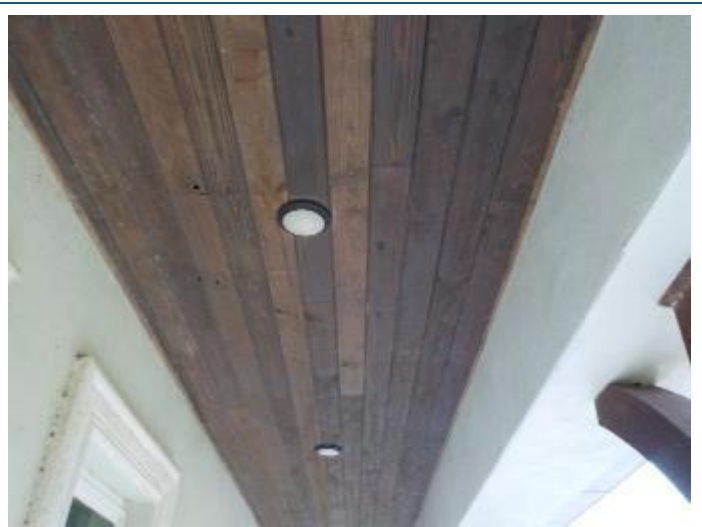
Photograph 46: Finish on T&G ceiling planks over front porch was damaged/deteriorated

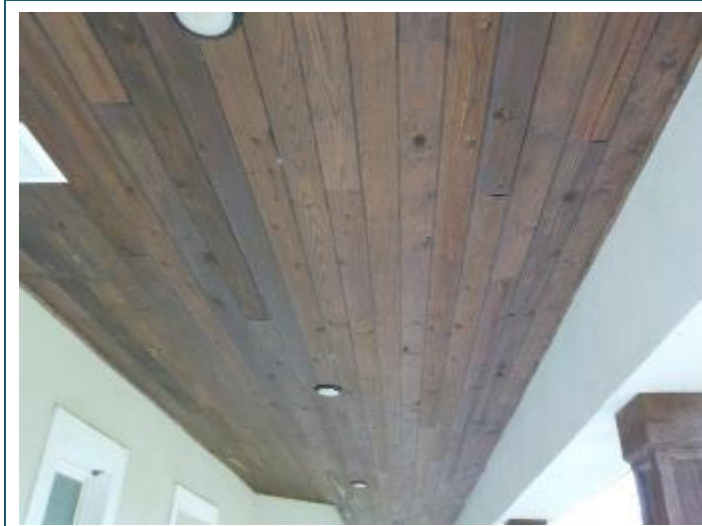
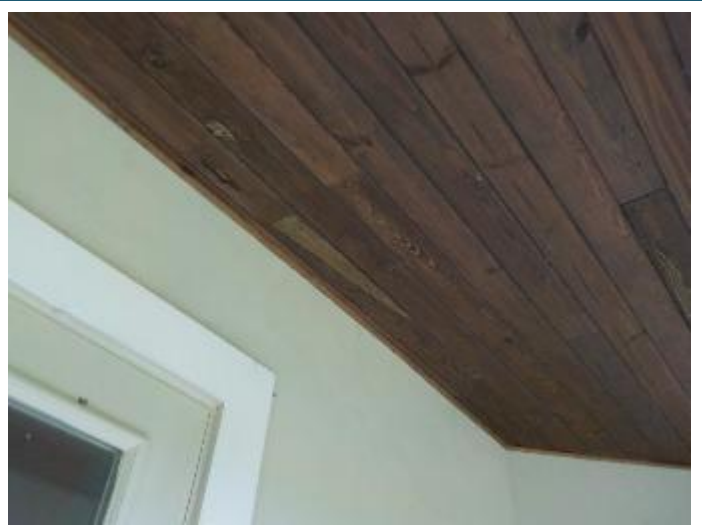
Photograph 48: Finish on T&G ceiling planks over back porch was damaged/deteriorated

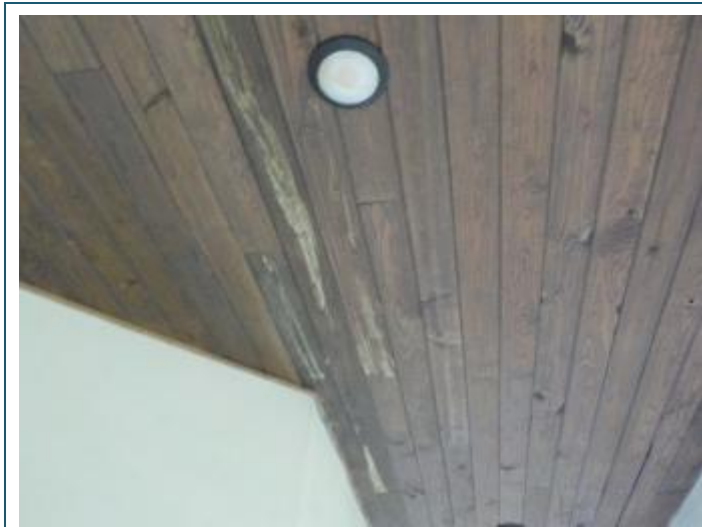
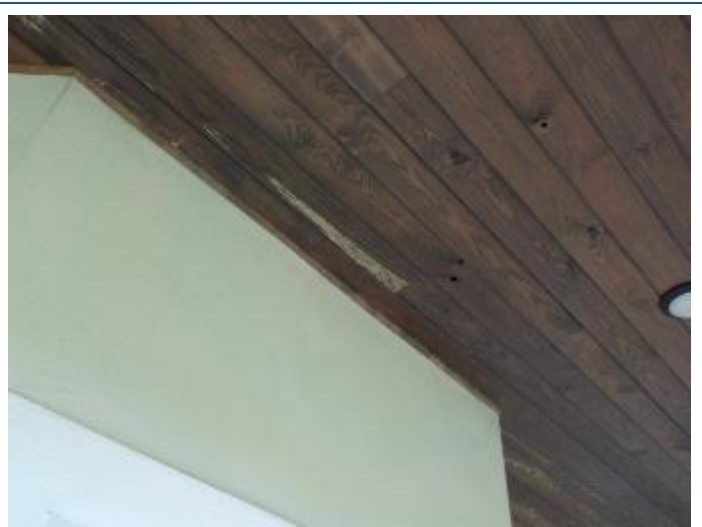
Photograph 50: Finish on T&G ceiling planks over back porch was damaged/deteriorated

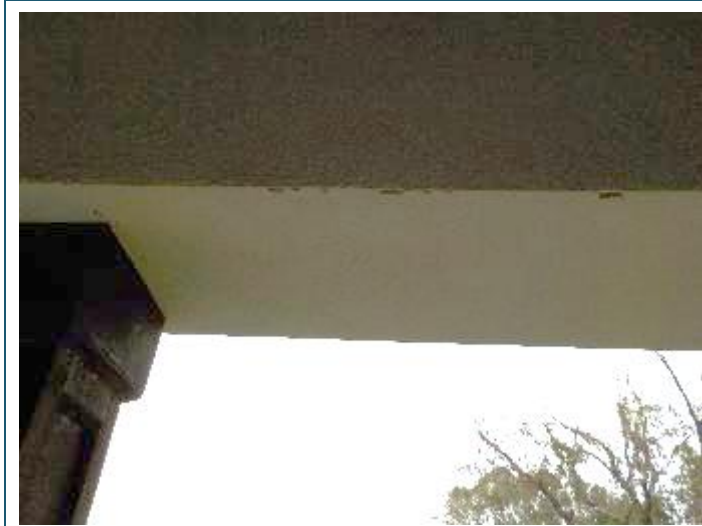
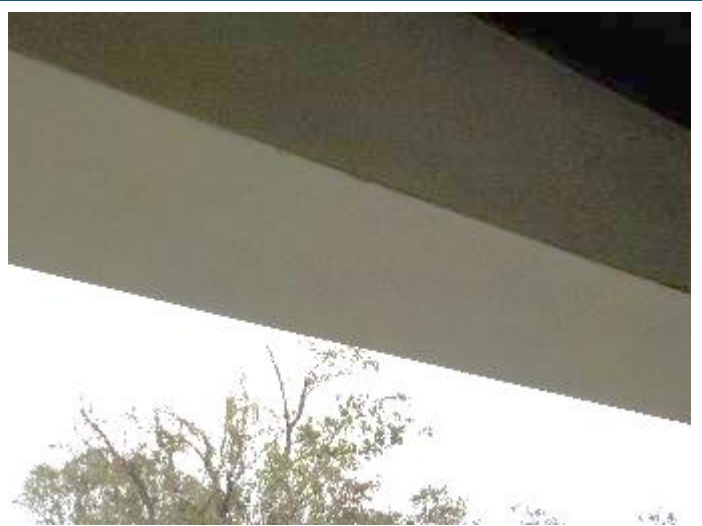
Photograph 52: Damage to exterior stucco along beam on back porch

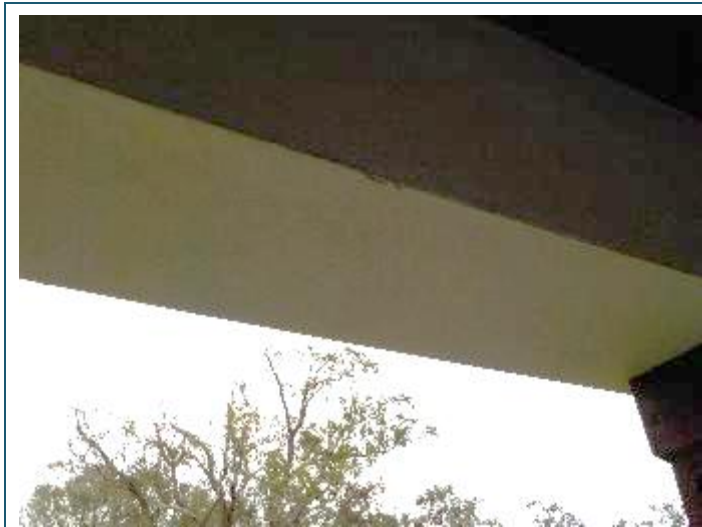
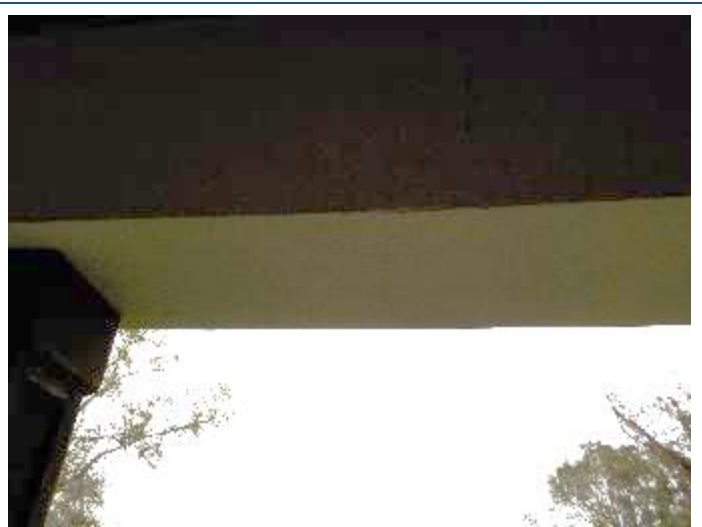
Photograph 54: Damage to exterior stucco along beam on back porch

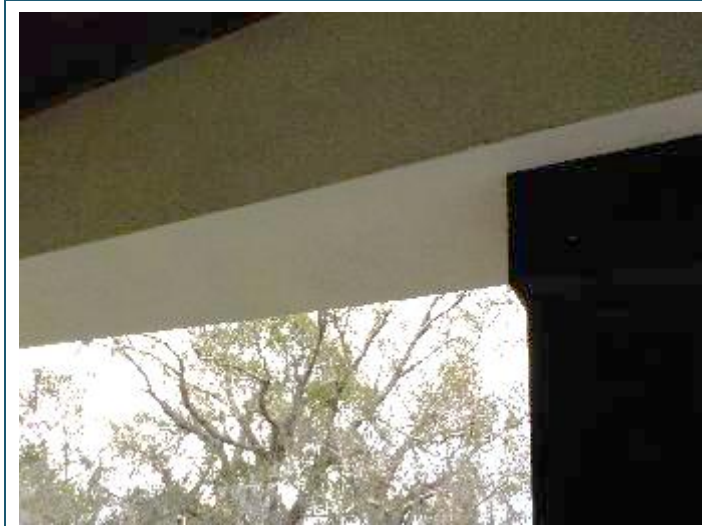
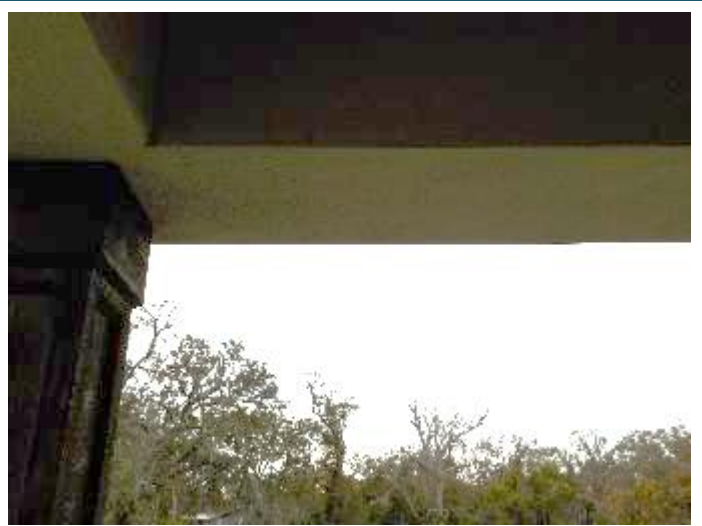
Photograph 56: Damage to exterior stucco along beam on back porch

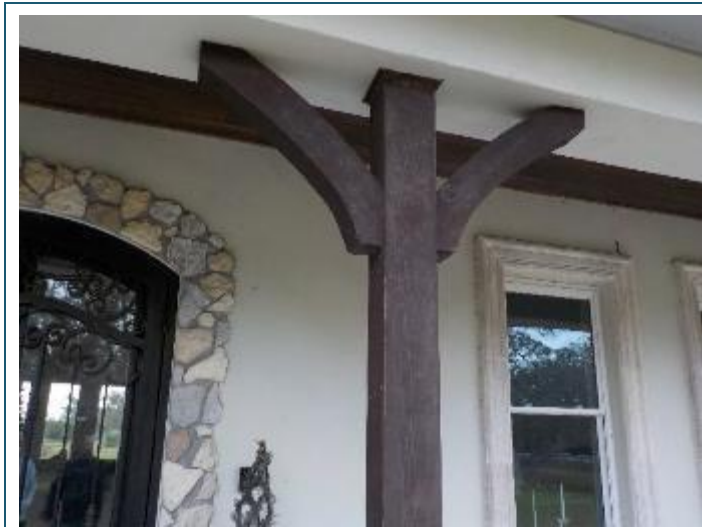
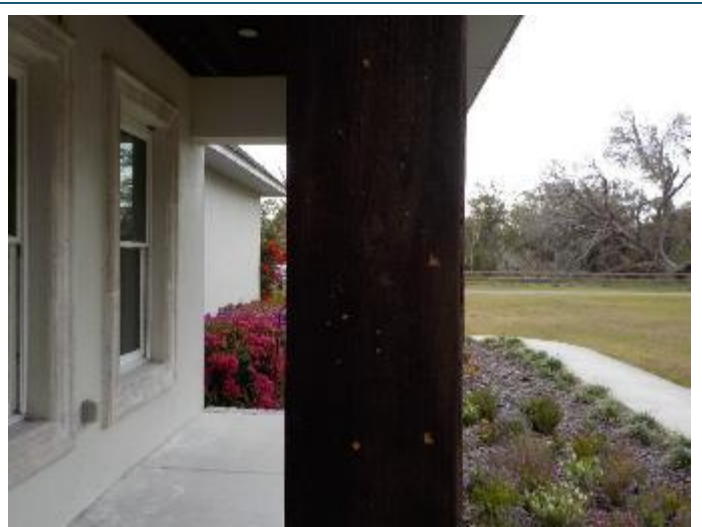
Photograph 58: View of wood pillar on front porch

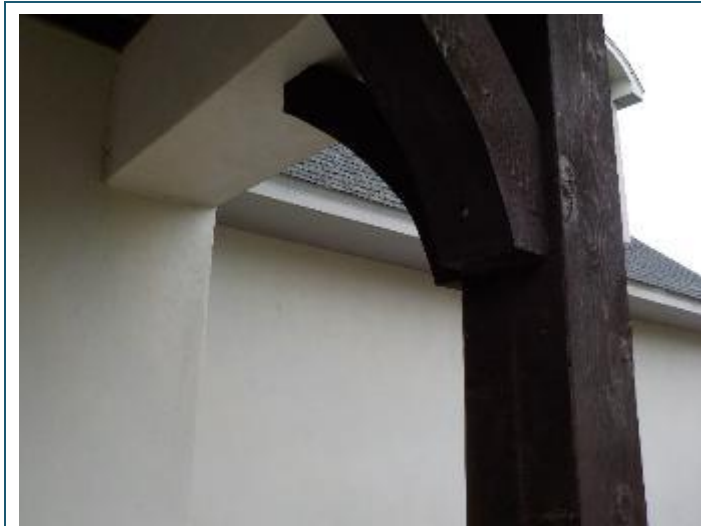
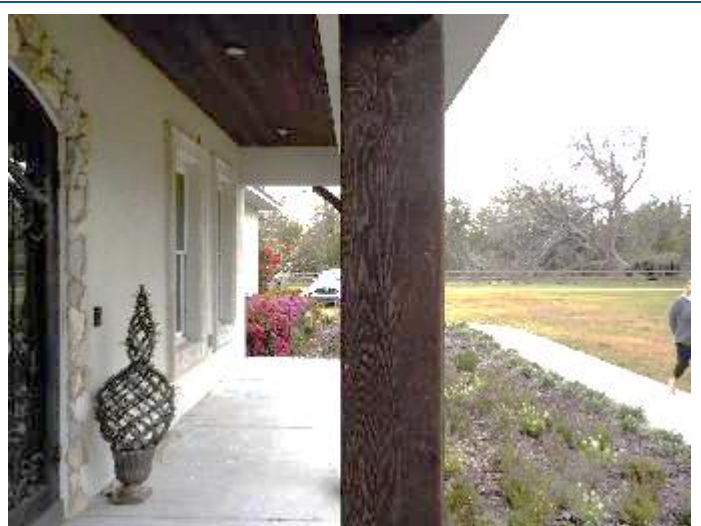
Photograph 60: Finish on wood pillar on front porch was damaged/deteriorated

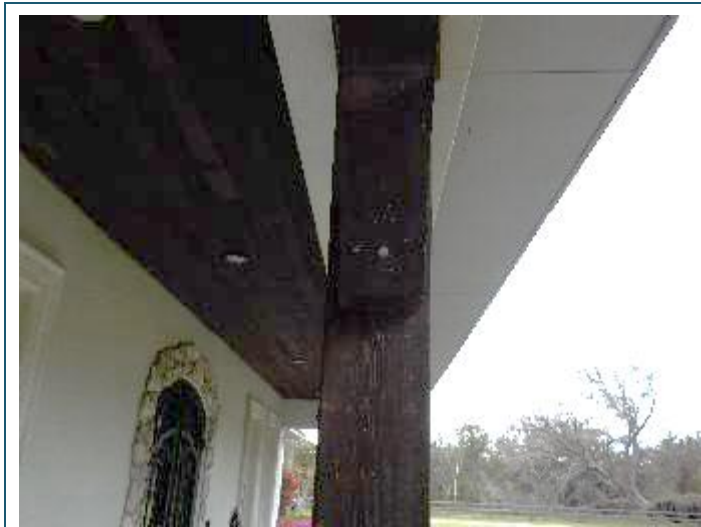
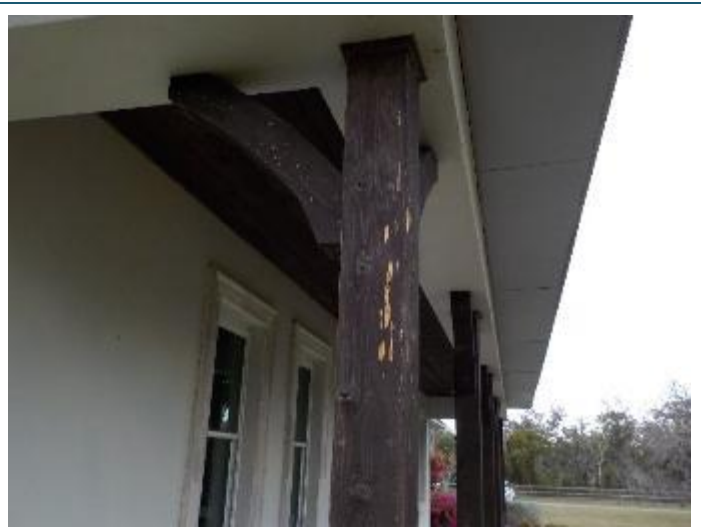
Photograph 62: Finish on wood pillar on front porch was damaged/deteriorated

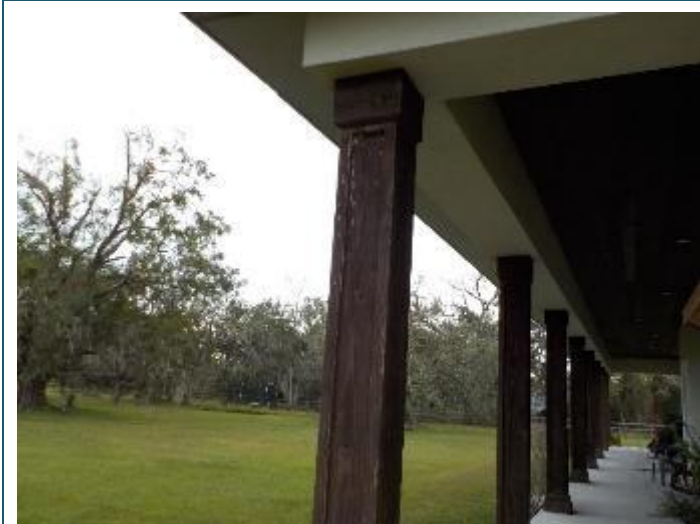
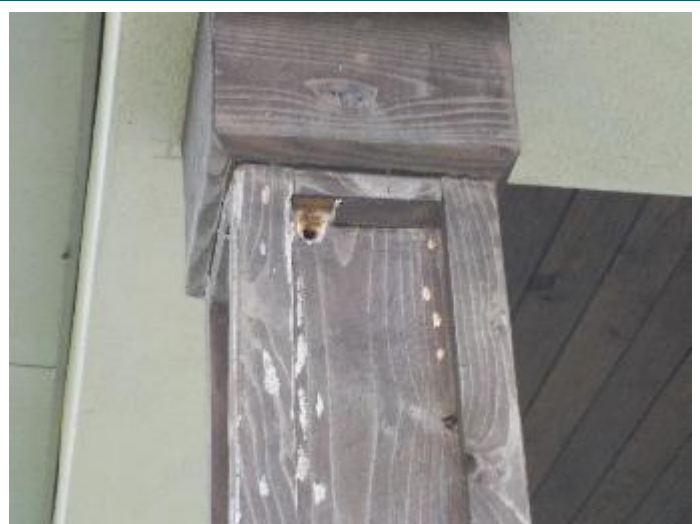
Photograph 64: View of wood pillar on back porch

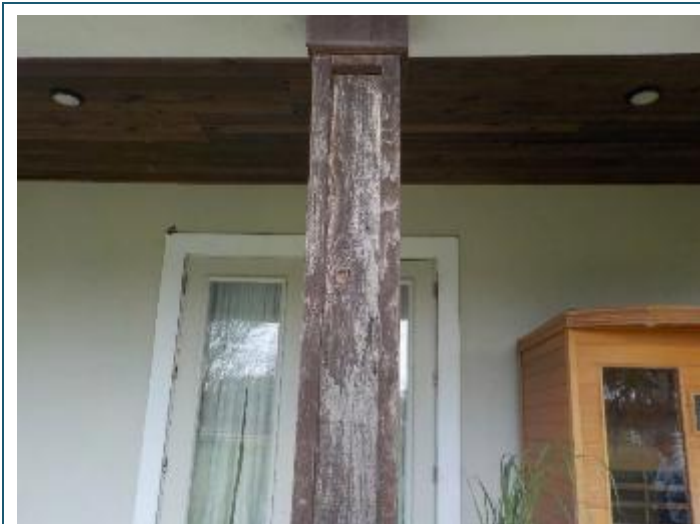
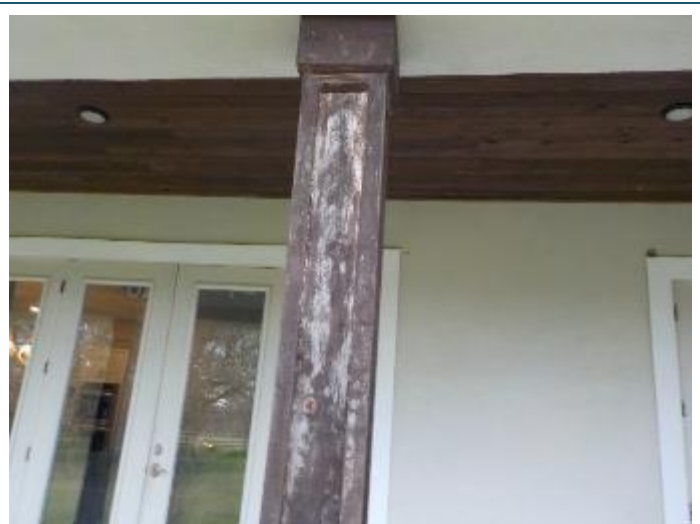
Photograph 66: Finish on wood pillar on back porch was damaged/deteriorated

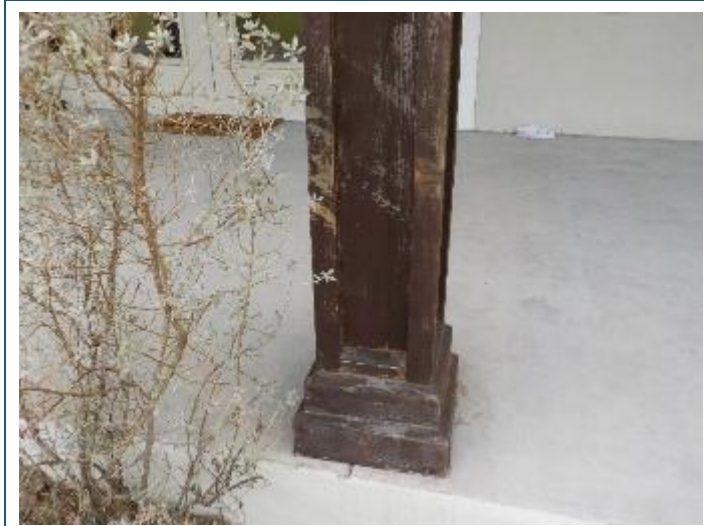
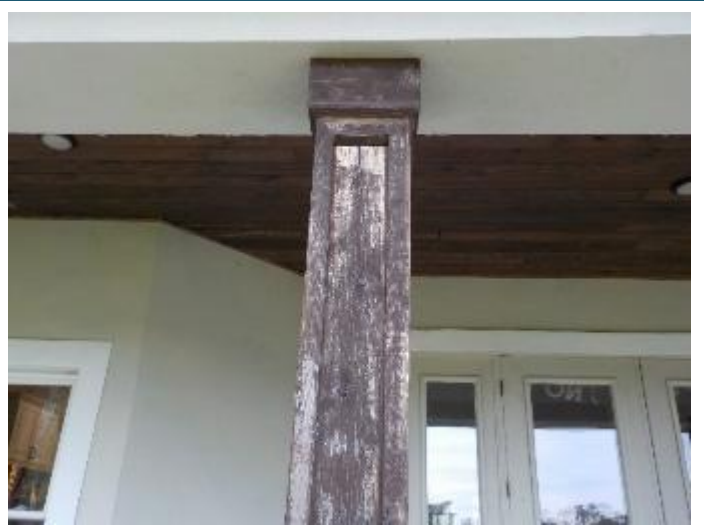
Photograph 68: Finish on wood pillar on back porch was damaged/deteriorated

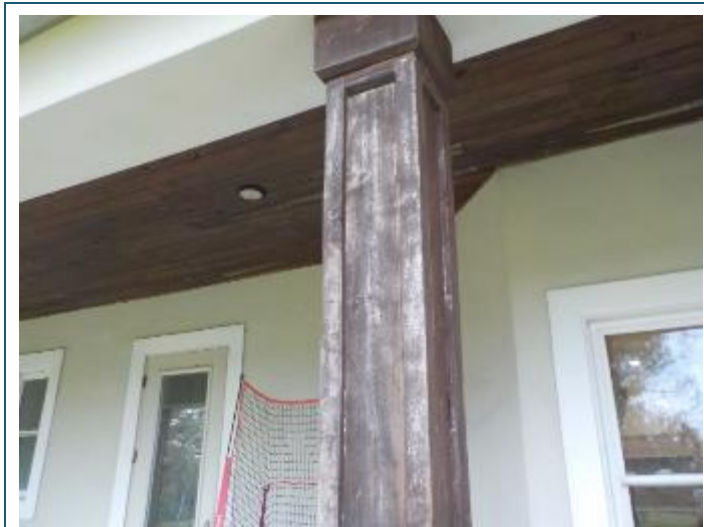
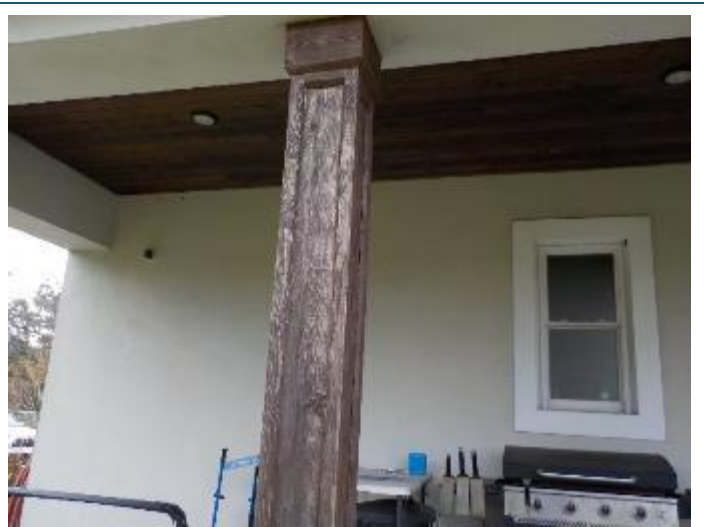
Photograph 70: Finish on wood pillar on back porch was damaged/deteriorated

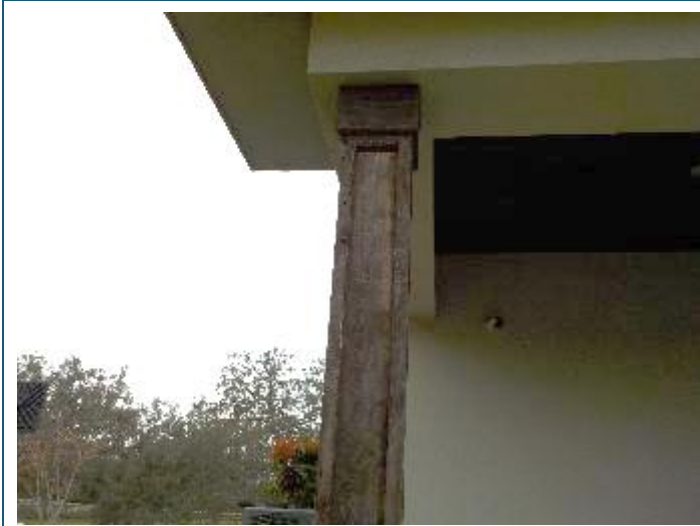
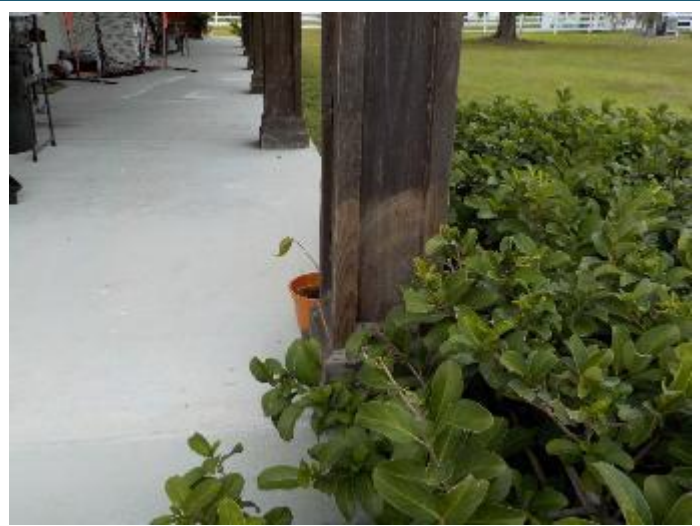
Photograph 72: Finish on wood pillar on back porch was damaged/deteriorated
