Engineering Assessment

Insured Names

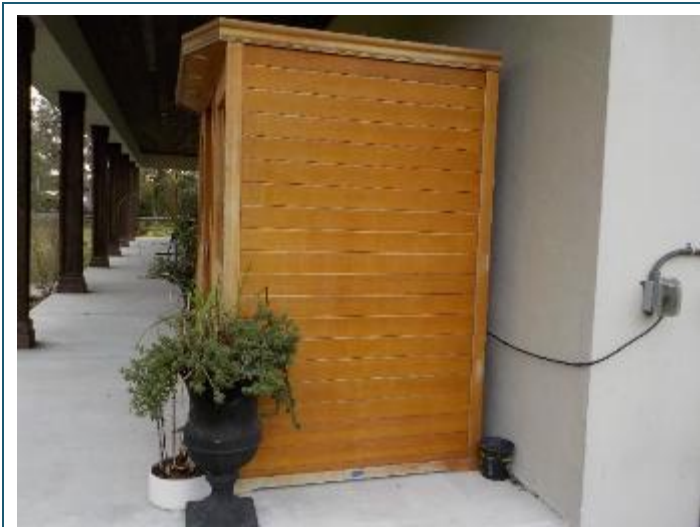
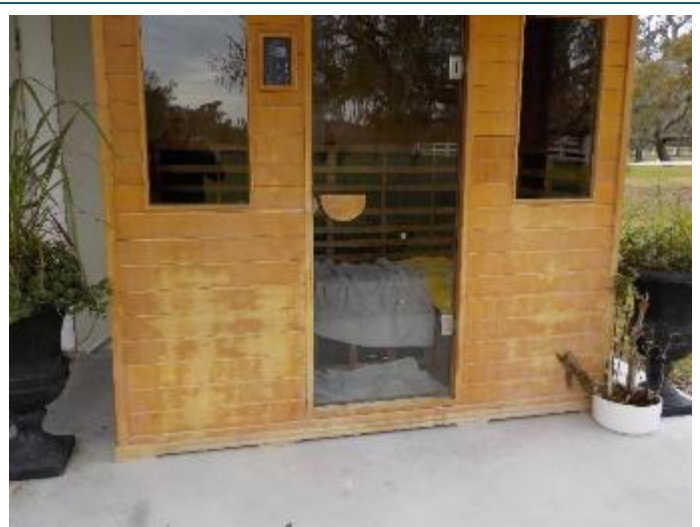
Photograph 74: Damage to exterior finish of sauna
